Effect of Type and Arrangement of  
Cellular Blocks on Strength of Prestressed Assemblies

M. Chi and D. Watstein

Bureau of Yards and Docks  
Department of the Navy

August 10, 1956

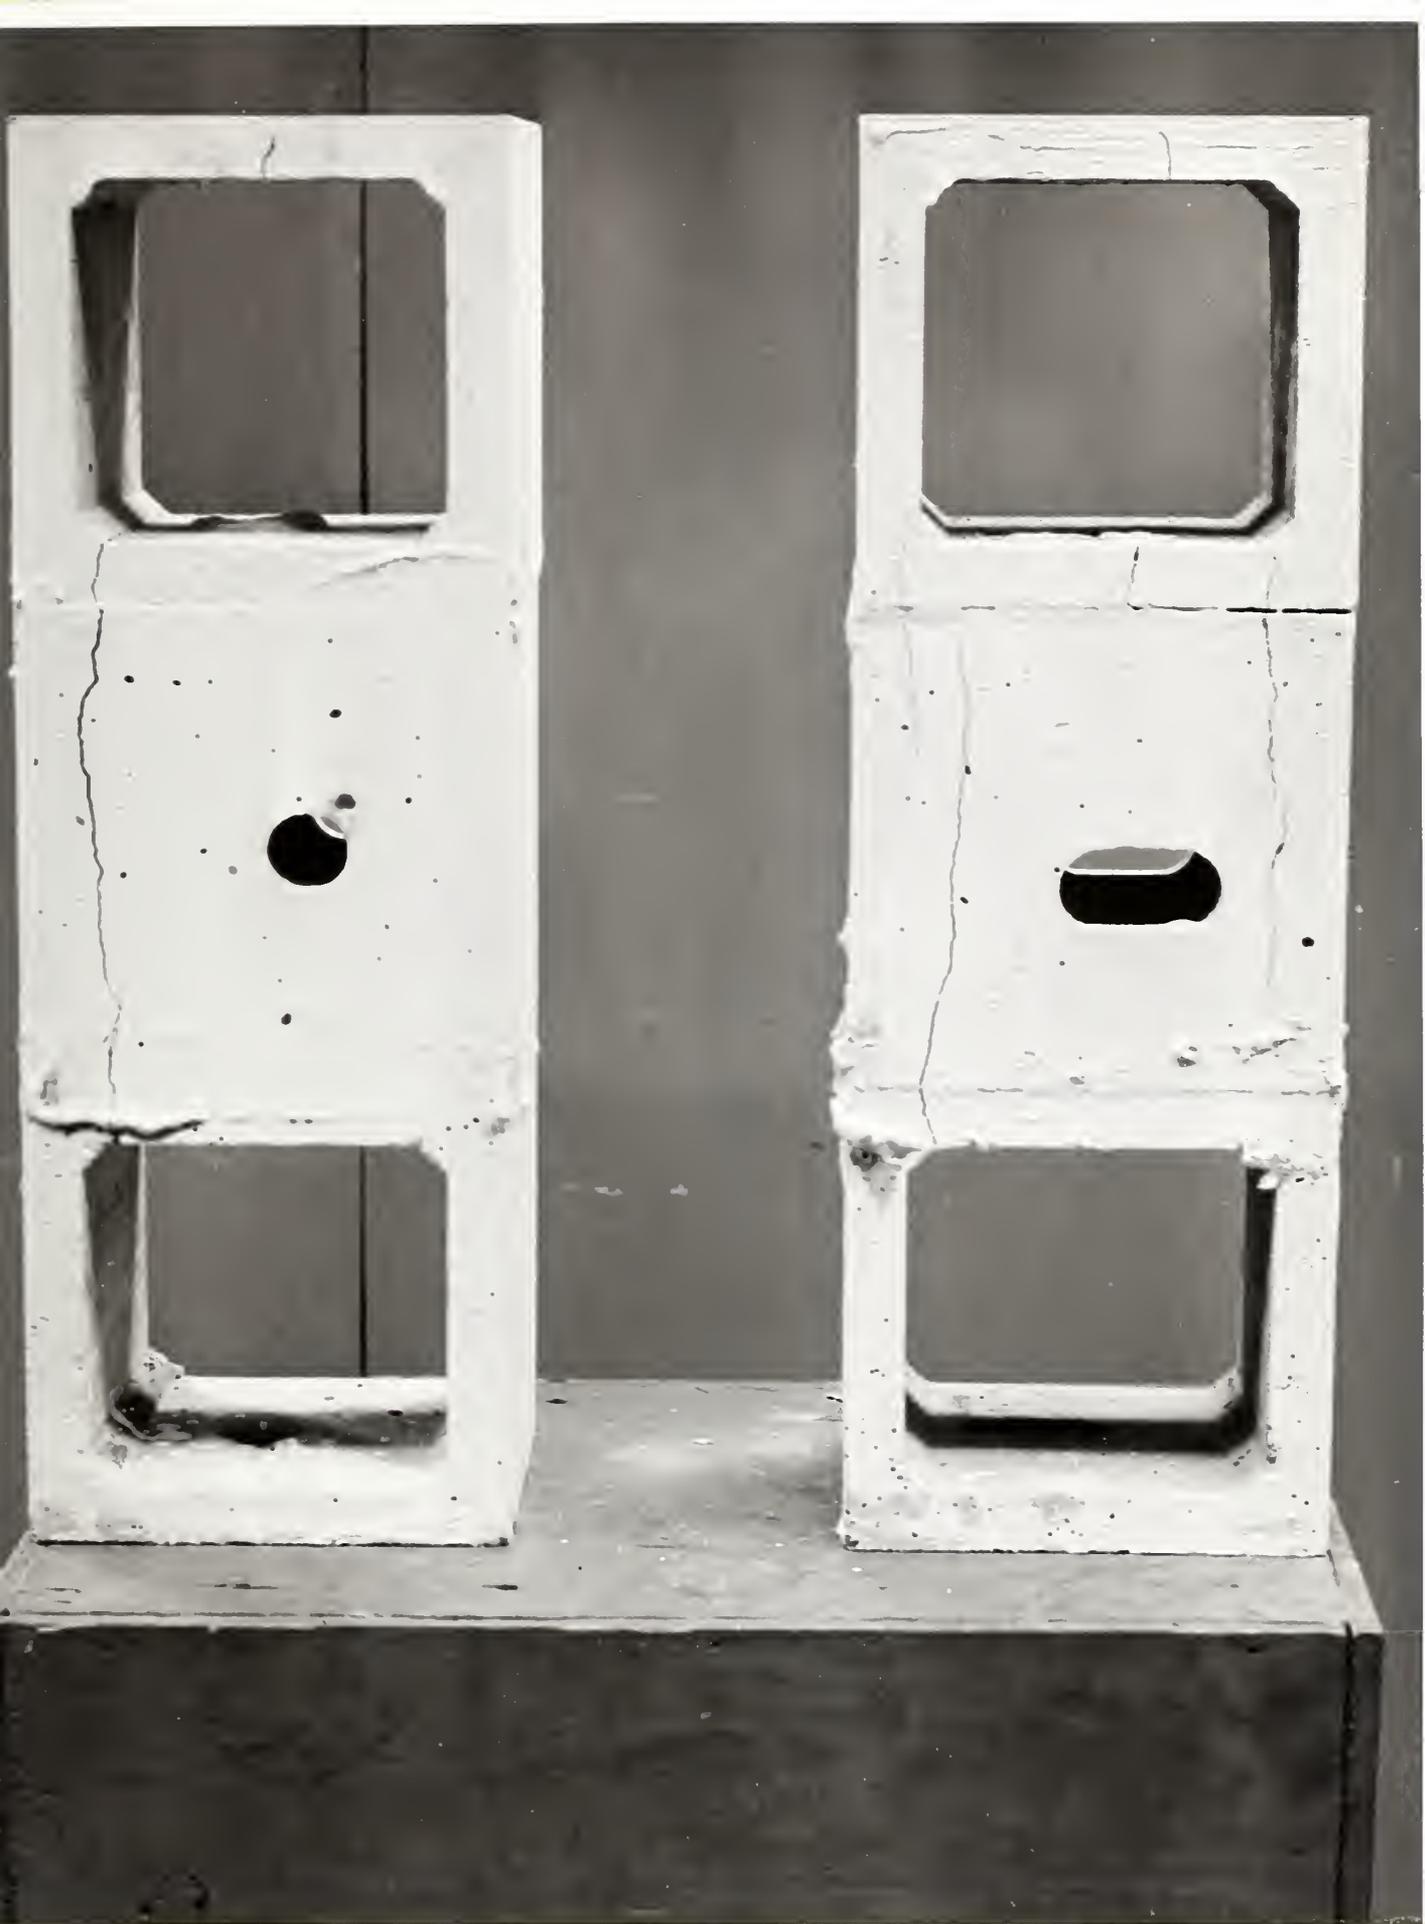
g. 16 - Typical crack pattern in columns with crisscross arrangement.
